Presented at: Institute for International Research, "Preparing for Changing Paradigms in High Purity Water", October 27 - 29, 1999, San Francisco, California

## **Rouging of Stainless Steel in WFI and High Purity Water Systems**

By  
John C. Tverberg  
Trent Tube

And  
James A. Ledden  
Pharmacia and Upjohn

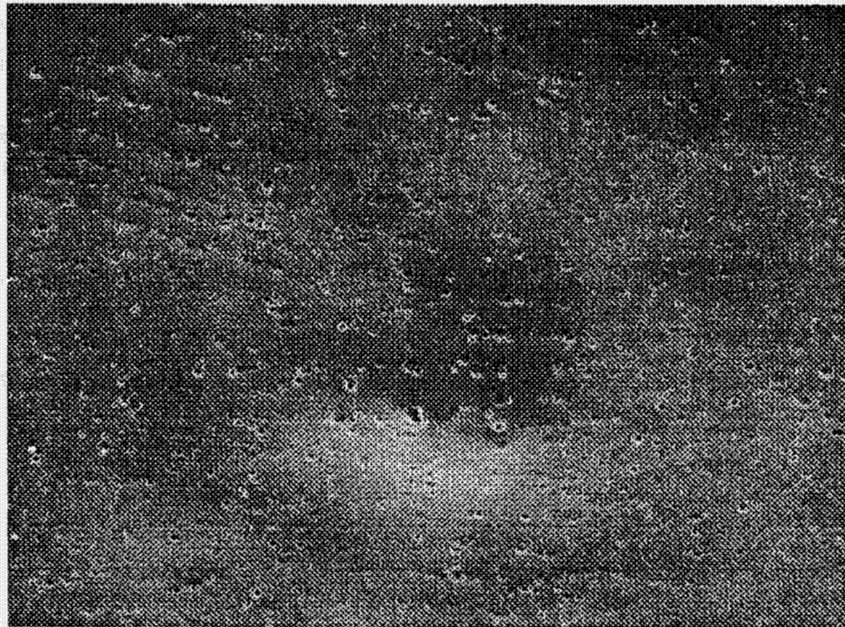
SEM examination of a "silver" surface in the WFI loop shows isolated oxide particles. These particles usually collect on inclusion pits within the grain or on grain boundaries. They are small, spherical particles that are widely separated as seen in Figure 1. The orbital welds have the particles attached to the ridges on the welds. The longitudinal factory weld appeared to have fewer particles than the base metal, possibly because the weld had fewer inclusions.

Figure 1: Small spherical particles on "silver" electropolished surface on Type 316L tubing from a WFI system. Origin appears to be external to the system. SEM 450X.

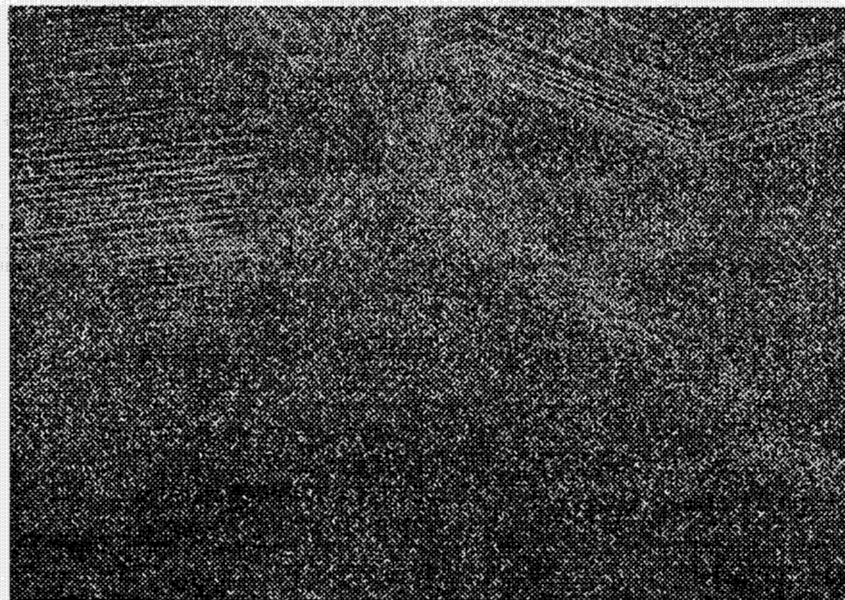
From the high purity loop of the same system, the magenta, or dark red surface, had a very thin layer of oxide, under which the electropolished finish is clearly visible. SEM examination shows a denser population of spherical oxide particles of smaller diameter than those on the silver surface. Location is not site specific as on the silver surface, but rather evenly distributed over the entire surface as seen in Figure 2.

Figure 2: Denser population of spherical oxides on a "magenta" electropolished Type 316L tubing surface from a Hi-Purity system. Origin appears to external to the system. SEM 450X.

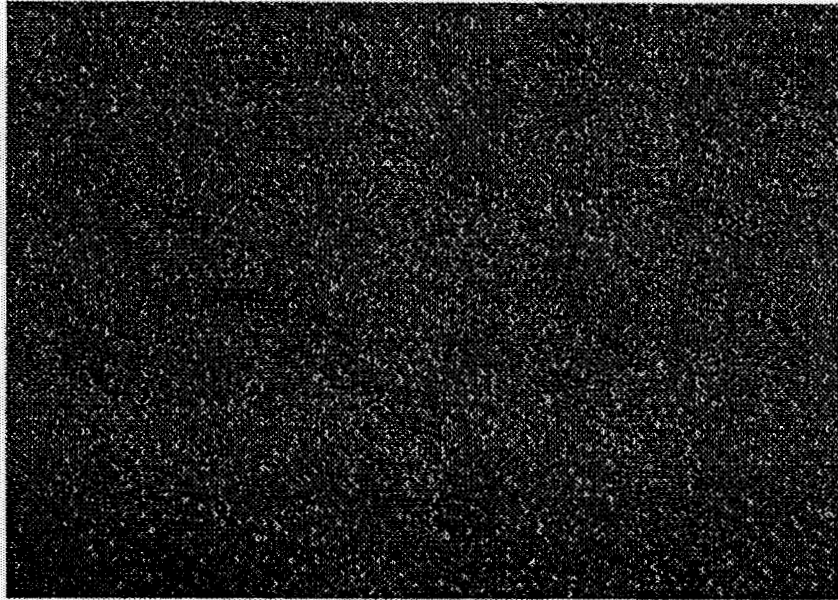
The orange surface may be the most interesting. Here the spherical particles are deposited heavily over the entire surface, layer upon layer like grains of sand on the beach. The sphere size appears smaller than those on the silver surface, but larger than the magenta surface. Figure 3 shows the surface appearance. The orbital welds have the same layered appearance, with the oxides following the contours of the weld surface.

Figure 3: Heavy layer of Rouge on an "orange" electropolished Type 316L tubing surface from a WFI system. The particle shape is spherical and smaller than those on the "magenta" surface and more densely packed. SEM 450X.

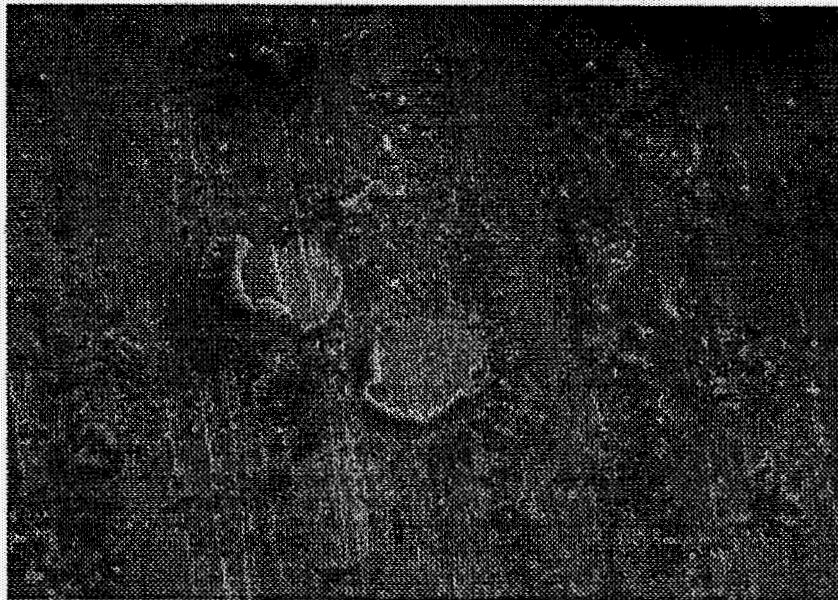
Examination of a section of tubing from another system, which used mechanically polished and non-passivated material, had a different appearance as in Figure 4. The oxides appeared to grow on the surface of the metal as blisters. In those areas where the blisters were knocked loose, bare metal was visible with areas of bright metal on the bare spots, similar to a stainless steel surface undergoing crevice corrosion. Removal of the oxide was difficult, especially in the non-blistered areas.

Figure 4: Oxide particles on a mechanically polished non-passivated Type 304L stainless steel surface. Note the areas where the oxide "bubbles" have burst and the bare metal underneath. The white streaks under the top burst bubble probably represents an active stainless steel surface SEM 450X.

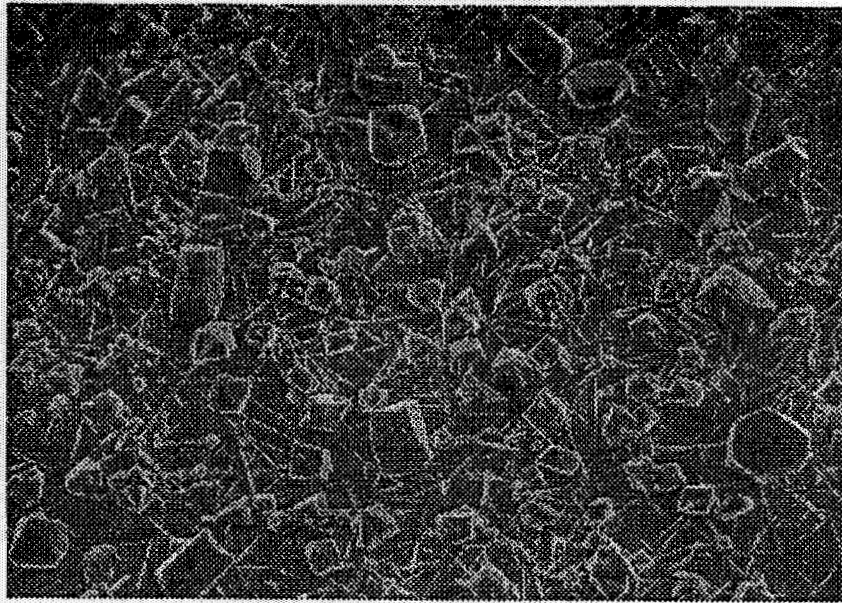
The third specimen came from a high temperature, high purity electropolished steam line operating at 350° F (175° C). Visually, this specimen had a glossy gray-black surface. The SEM showed distinct crystals on the surface of a crystalline base as shown in Figure 5. These crystals match the octahedral and dodecahedral shape for magnetite crystals. They appear to be growing together in some areas to produce a heavier film. The underlying crystal base is continuous and appears to be the initial stage of this type of rouge development.

Because of the limited diffusion of oxygen, in this case because of the presence of chromous oxide, the two oxides possibly coexist in the same octahedral unit cell. In this rouge form some of the ferrous oxide may be replaced with nickel oxide. The SEM photograph clearly illustrates the octahedral crystal form.

Figure 5: The highly crystalline surface of the gray-black glossy electropolished Type 316L stainless steel tube surface from a steam line. The subsurface crystals appear continuous and the top crystals appear to be joining together. Their crystal form is both octahedral and dodecahedral. This is typical for magnetite. SEM 450X.

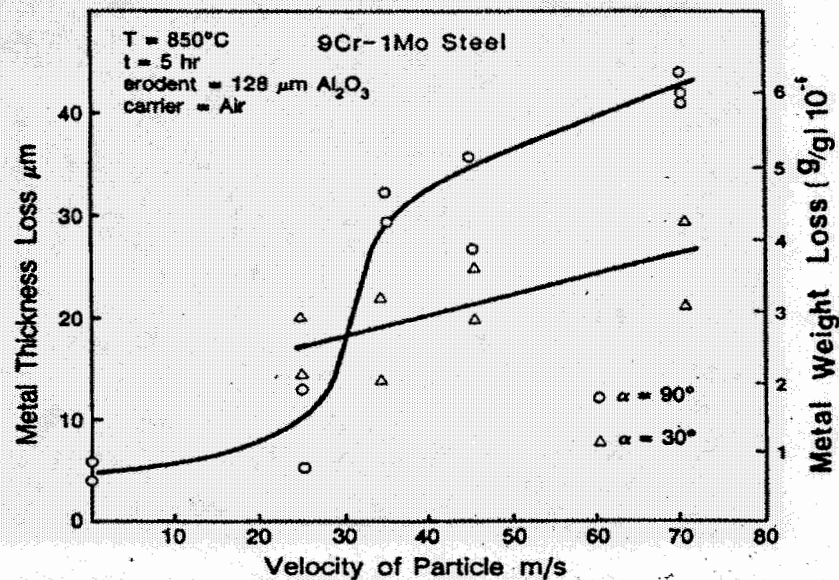
Because the composition of the corrosion product so closely matched the composition of stainless steel and because the SEM appearance of the particles was spherical, it seems that the origin is either the pump or the feed lines to the pump. The feed lines showed no evidence of rouging, therefore the source may be the impeller or volute of the centrifugal pump. At the flow rate for this system and the diameter of the pump impeller, the velocity of a water particle emerging from the tip of the impeller can exceed 180 feet per second (fps). According to Levy<sup>9</sup>, high chromium steels will have a critical erosion rate around 100 fps as illustrated in Figure 6. At this velocity the erosion rates increase ten fold. Although this figure is not for stainless steel, it representative of a high chromium ferrite, similar to the delta ferrite that may exist in many pump impeller castings. Uhlig<sup>10</sup> suggests that particles of metal may be "blasted" from the metallic surface by the shock waves generated by cavitation, a rather common condition with centrifugal pumps.

Figure 6: Metal thickness loss versus velocity illustrating critical erosion velocity point at ~ 100fps where the metal loss increases by a factor of nearly 10. From Levy<sup>9</sup>.
